# Multifamily Domestic Hot Water Recirculation Survey

## Final Report

ET24SWE0061

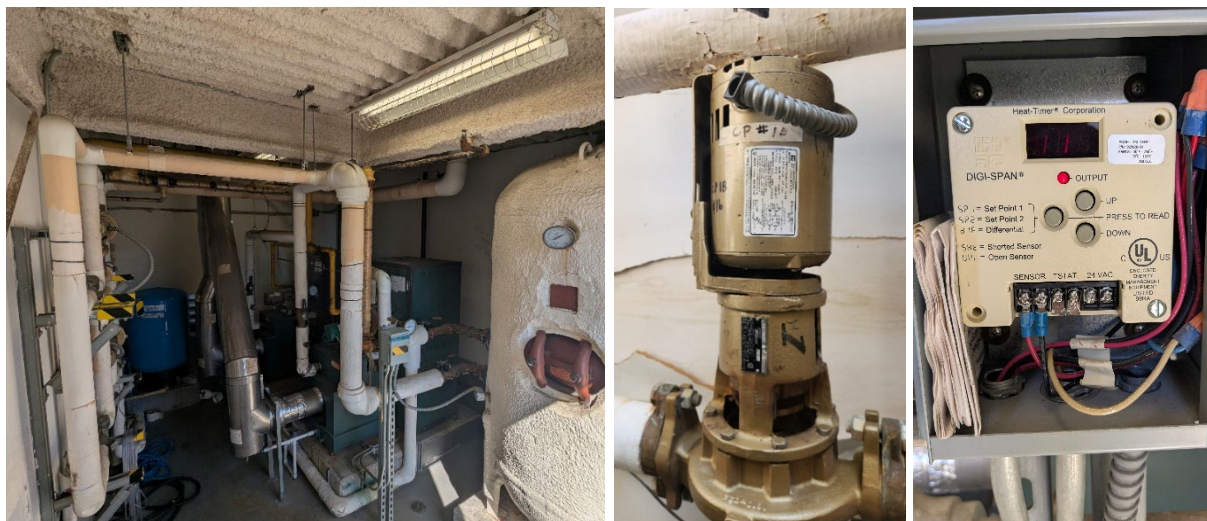
**Figure 3: Site 1 DHW system mechanical room, recirculation pump, and controller.**

The initial hot water system for Site 1 is shown in [Figure 3](#), comprising two 750 MBtu/hr natural gas water heaters, a 600-gallon storage tank, ½ hp constant speed recirculation pump, and a two-stage digital setpoint controller. The insulation in the mechanical room was aged, with some exposed fittings and valves, but was generally in good condition.

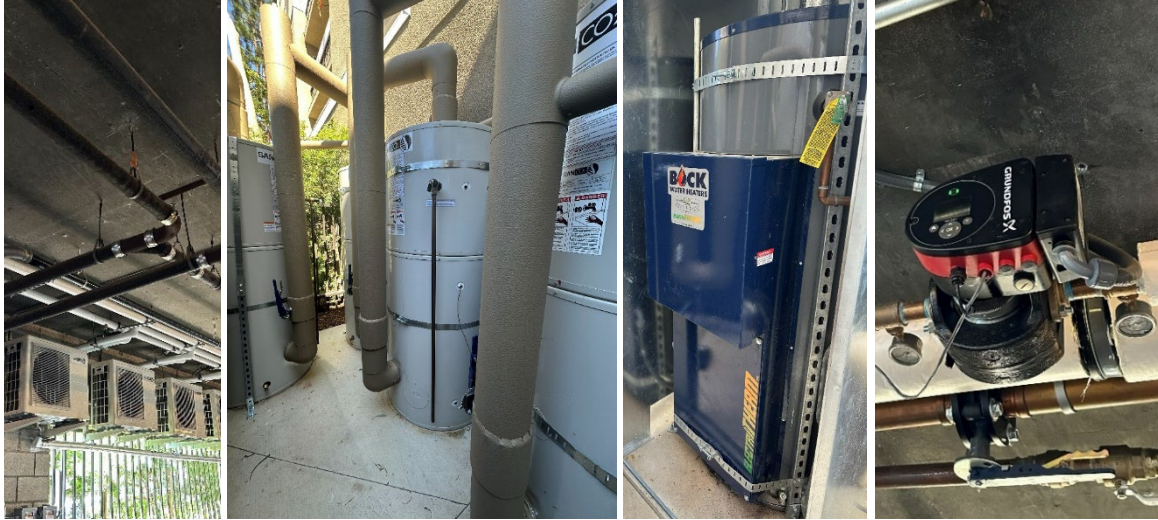
**Figure 6: Site 3 HPWHs, storage tanks, swing tank, and recirculation pump.**

The water heating system installed in late 2025 is a CHPWH system with eight 4.5 kW CO<sub>2</sub> HPWHs and an electric resistance swing tank for temperature maintenance. [Figure 6](#) shows the water heating system comprising of a bank of HPWHs, 800 gallons of primary storage, a 13.5 kW electric resistance swing tank, and recirculation pump set at constant return temperature of 115°F.

Exposed piping is well-insulated, with rigid foam insulation on all exterior piping and fiberglass insulation on all visible interior piping, except for a small portion of the recirculation line where the pump is located. The indoor piping has jacketed fiberglass insulation that is one inch thick on the hot water return (HWR) lines whereas the insulation is about two inches thick on the HWS lines. Any existing pipes between walls were left uninsulated according to the maintenance team.

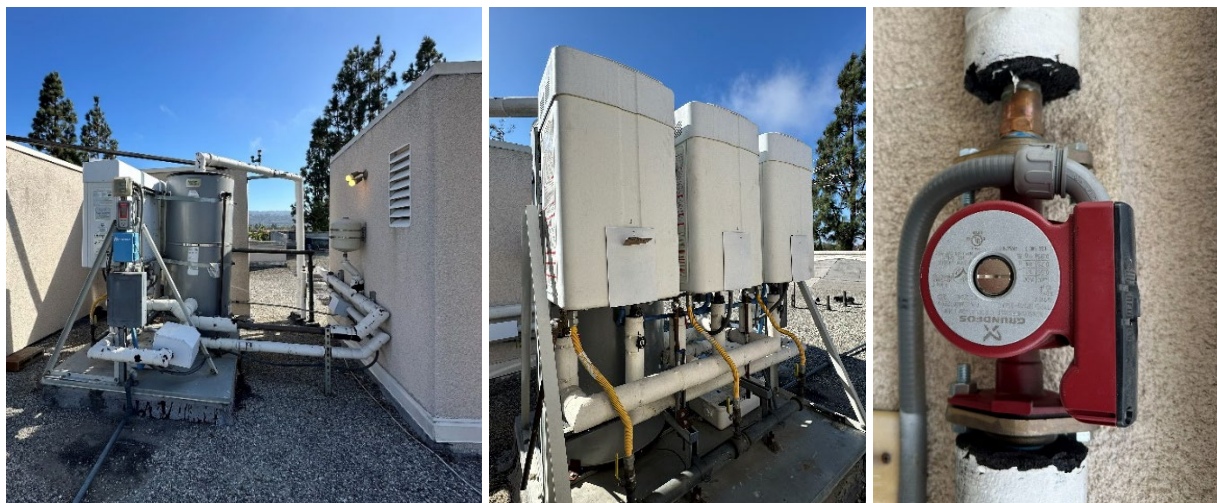
**Figure 7: Site 4 hot water system, water heaters, and recirculation pump.**

The rooftop gas-fired hot water system shown in [Figure 7](#) was installed in 2023 according to the maintenance team. The system comprises three 200 MBtu/hr natural gas hot water heaters, a 119-gallon storage tank set at 115°F, and constant speed recirculation pump.

The hot water system has black elastomer insulation with a UV coating on most of the pipes. It is one inch thick on the recirculation piping. A small portion of insulation that was missing along the piping was replaced for continuity.

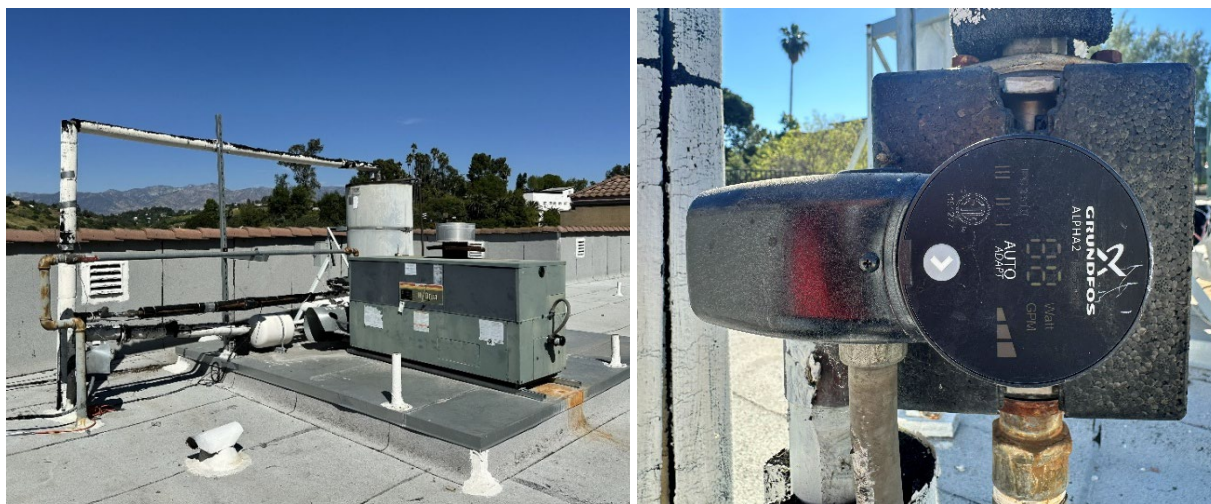
**Figure 8: Site 5 DHW system and recirculation pump.**

Each hot water system consists of a 750 MBtu/hr natural gas boiler, storage tank set at 120°F, and variable speed recirculation pump set to operate at constant flow as seen in [Figure 8](#).

The outside pipe insulation on both systems is one-inch-thick elastomeric foam with a UV coating that has been weathered from constant exposure to the elements. As a result, the coating is deteriorated in several locations and gaps are present in the insulation.

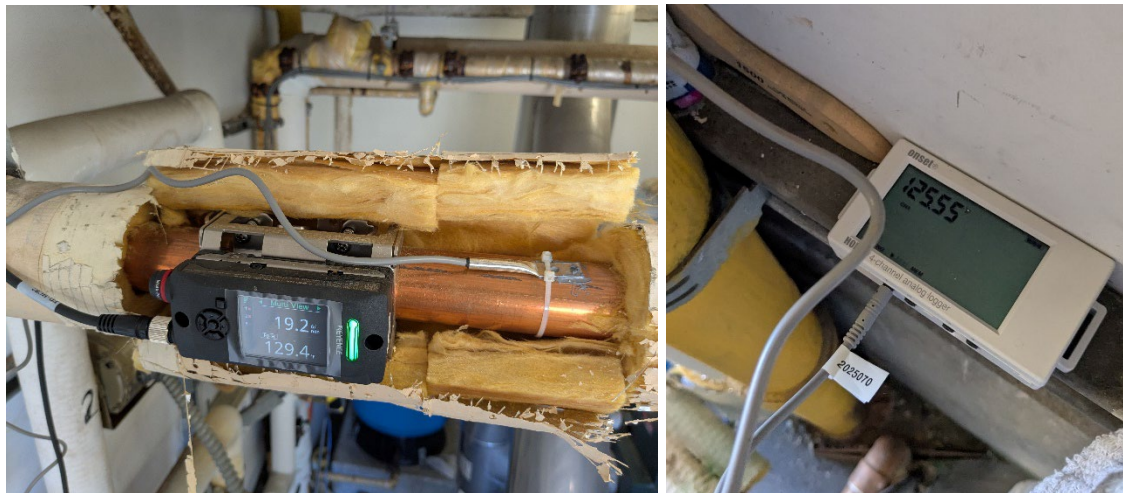
Figure 10 shows a sample of the M&V equipment deployed in the field, which includes the flow meter installed on the recirculation return pipe and the temperature sensor and its corresponding data logger. The insulation was re-sealed over the temperature sensor after installation to ensure accurate pipe temperature readings.

Figure 10: Flow meter and return water temperature sensor installation (left) with temperature logger (right).

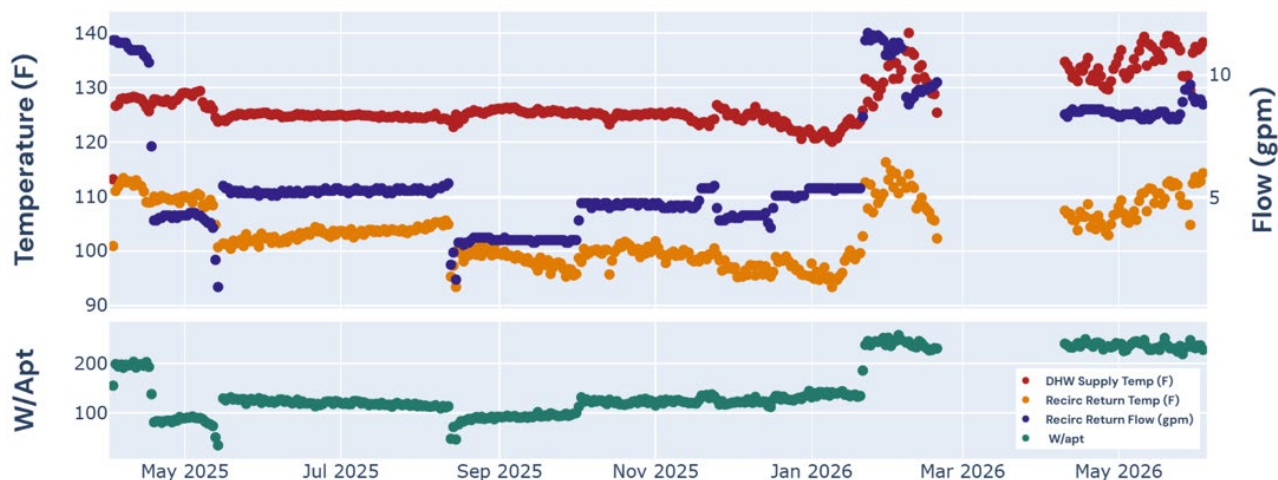
This case demonstrates that crossover can substantially affect measured distribution losses. Here, monitoring data and tenant complaints made the issue obvious, but crossover can also occur on a much smaller scale while still inflating measured distribution losses.

**Figure 15: Increase in measured recirculation losses at Site 14 after crossover event.**
